³ RARITAN RIVER BASIN,
COLD BROOK, HUNTERDON COUNTY,
NEW JERSEY.

² J. SEWARD JOHNSON
DAM LEVEL
NJ 00770

PHASE 1 INSPECTION REPORT

⁶ NATIONAL DAM SAFETY PROGRAM.

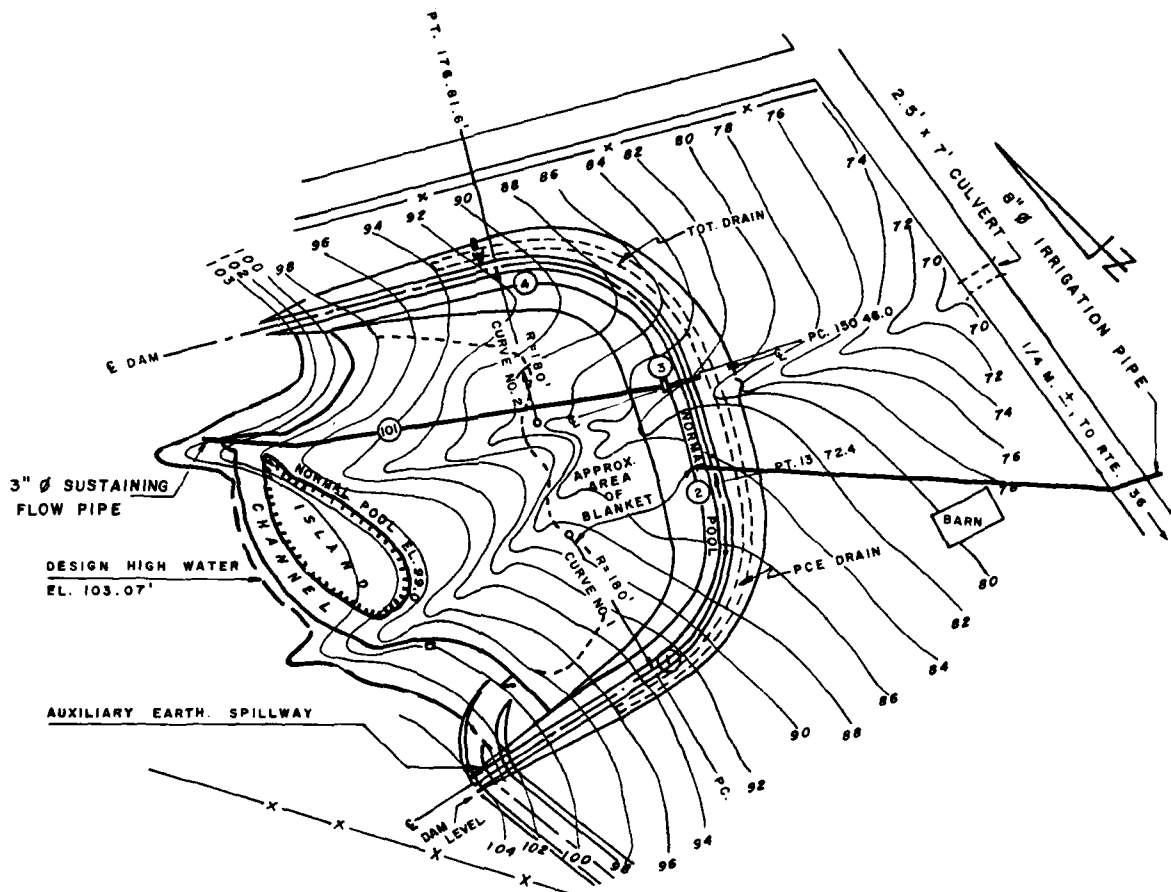
FIGURE 2

The embankment is a crescent-shaped structure (see Figure 2) constructed on a gentle and uniformly sloping hillside. Matted grass on the crest indicates the presence of an occasional vehicle, although severe rutting was not observed. Heavy brush and an occasional young conifer were noted in scattered areas on the left half of the downstream embankment, while somewhat thinner growth covered the upstream face of the dam. The alignment of the crest is satisfactory. No slumping, cracking, or seepage was observed although some rodent burrows were noted on the downstream slope and light erosion was evident at several locations on the upstream face.

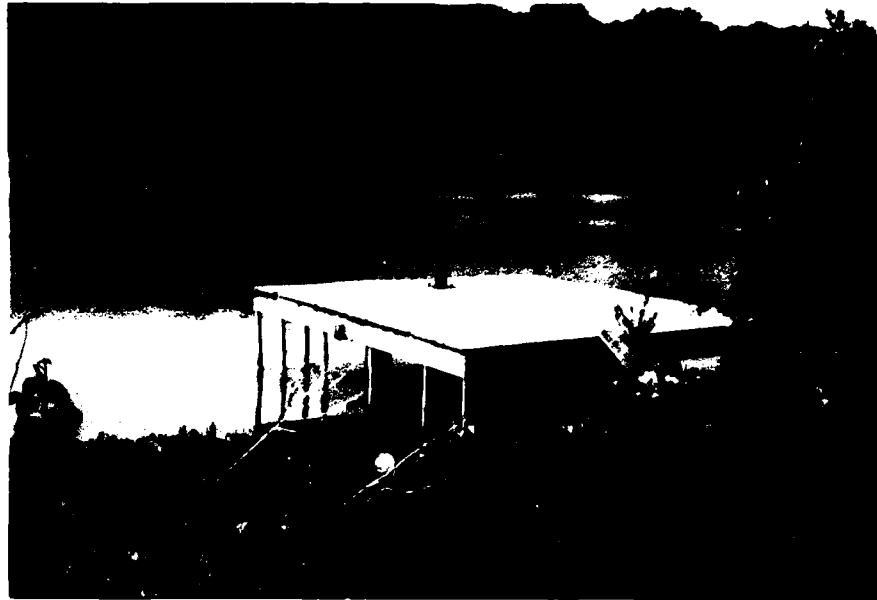
VISUAL EXAMINATION OF	OBSERVATIONS	REMARKS OR RECOMMENDATIONS
CRACKING AND SPALLING OF CONCRETE SURFACES IN OUTLET CONDUIT	None Observed	
INTAKE STRUCTURE	Light efflorescence noted on deck slab. No debris around intake to drop inlet.	Drop inlet structure in good condition.
OUTLET STRUCTURE	Some surface weathering of headwall. Completely overgrown with vines.	Vegetation should be cleared, light patching performed if necessary.
OUTLET CHANNEL	Small rocky-bottomed stream with lush vegetation along both banks.	
EMERGENCY GATE	Gate is reported operable by owner. Appears in good condition.

View of Principal Spillway Intake Structure

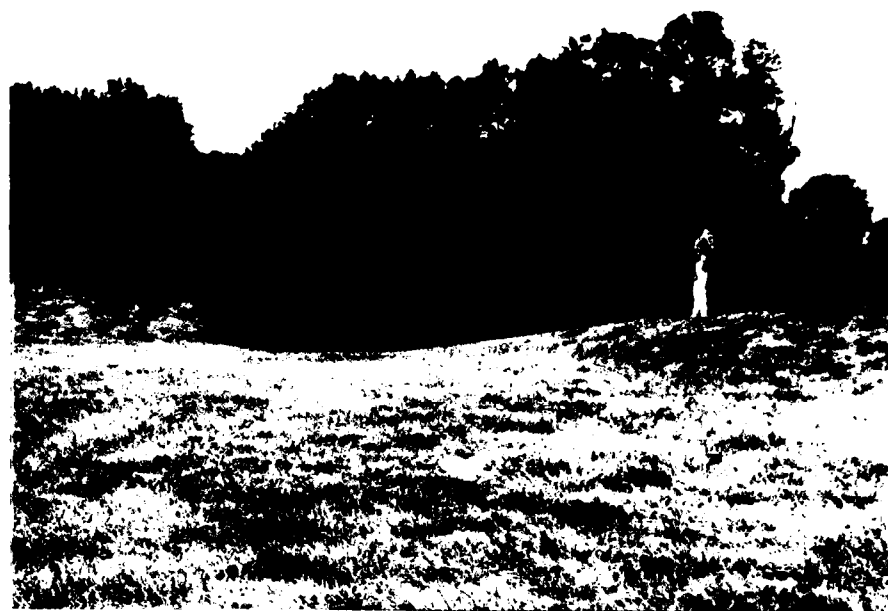
VISUAL EXAMINATION OF	OBSERVATIONS	REMARKS OR RECOMMENDATIONS
CONCRETE WEIR	No concrete. Level section is grass.	Well landscaped. Grass is 6-8 inches tall.
APPROACH CHANNEL	Very heavy brush and shrubs at entrance to approach channel. May retard inflow.	Shrubs and brush should be cleared from channel at the lake's edge.
DISCHARGE CHANNEL	Clear, well-maintained grassy slope.	Satisfactory condition.
BRIDGE AND PIERS	None	
	v

August, 1980
View of Auxiliary Spillway Channel

(1) Clear the heavy brush from the embankment, upstream face of the dam, and the entrance to the auxiliary spillway approach channel, insuring that a durable grass cover is established in its place.

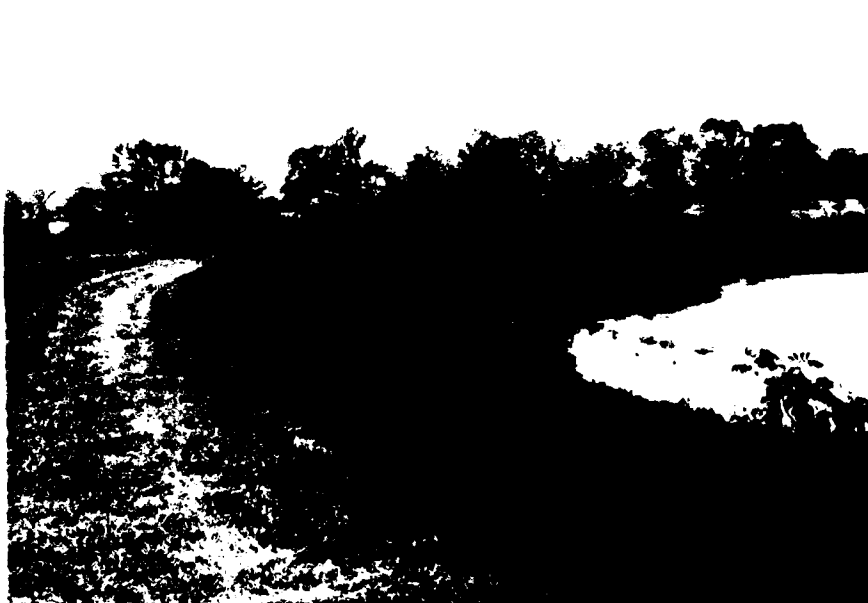
View of Dam Crest Looking Southwest
